Bureau Enquêtes-Accidents

REPORT

*on the accident on 12 November 1999
North of Pristina (Kosovo)
to the ATR 42-300 registered F-OHFV
operated by SI FLY*

F-FV99112A

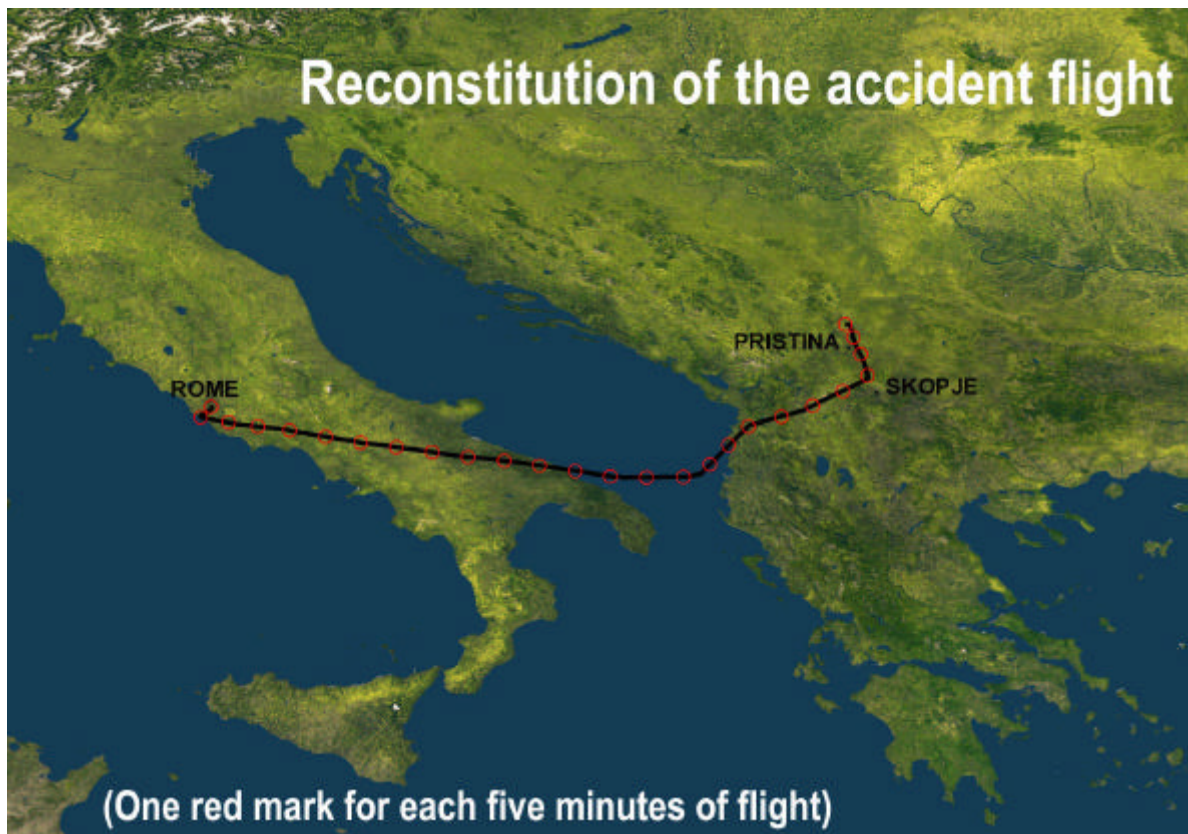
Figure 1 : Track of the accident flight

At 10 h 14 min 33 s, the CRC alarm was heard, the crew noted 240 feet on the radio altimeter. Two seconds later the aircraft struck high ground.

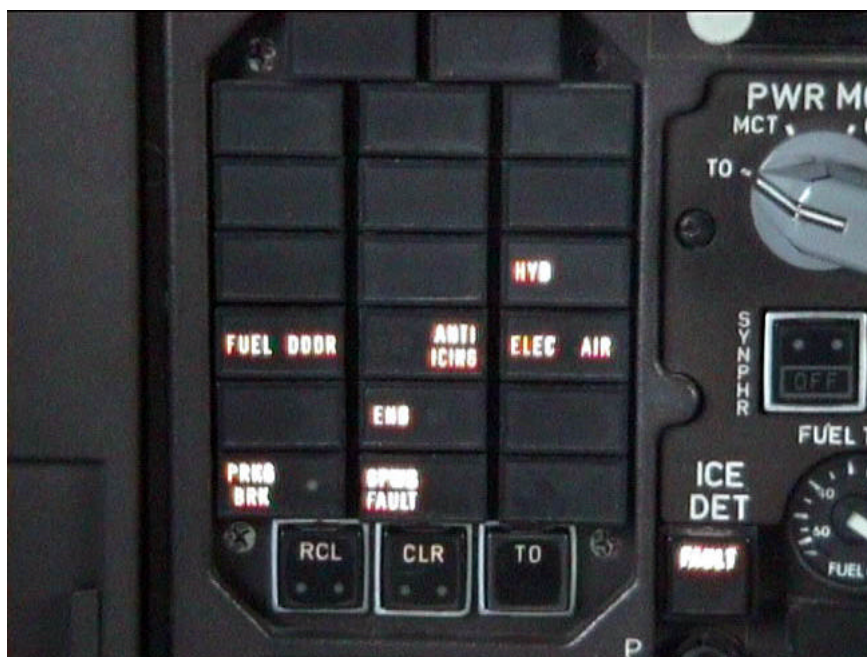
Figure 7 : Crew Alert Panel

The GPWS has an integrated test, which, in case of breakdown of one of the parts of the system, can display a "GPWS FAULT" warning on the Crew Alert Panel (CAP) : the "GPWS FAULT" warning is also displayed when the GPWS switch is in the OFF position.

GPWS Computer S/N 6697 was sent to Dinard for repair in the LAB workshops. Workbench examination showed a connection fault on the power supply card. This fault caused intermittent lighting of the GPWS FAILED light on the test bench. It would have provoked lighting of the GPWS FAULT light in the cockpit.

In addition, in a letter dated 24 September 1999, Si Fly informed ATR that despite the replacement of the computer, the GPWS was still not working properly and the "FAULT" indication was still "ON". Suspecting that the failure might originate in the radio altimeter, Si Fly also requested that ATR send them a new radio altimeter.

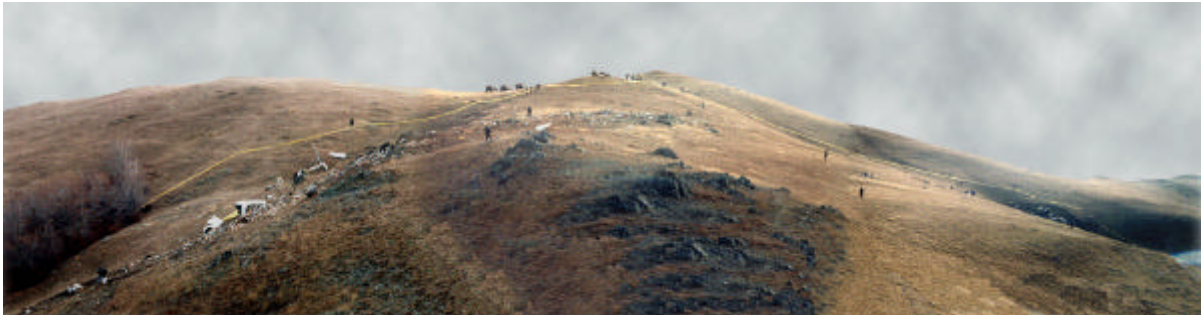
Figure 11 : View of accident site

The accident site is situated 25 NM north of Pristina Aerodrome (10 NM NE of Mitrovica) at an altitude of 4,600 feet. The first impact occurred 15 metres from the top of a ridge, in a rocky mid-mountain area. The peaks in this area vary between 3,380 and 5,800 feet.

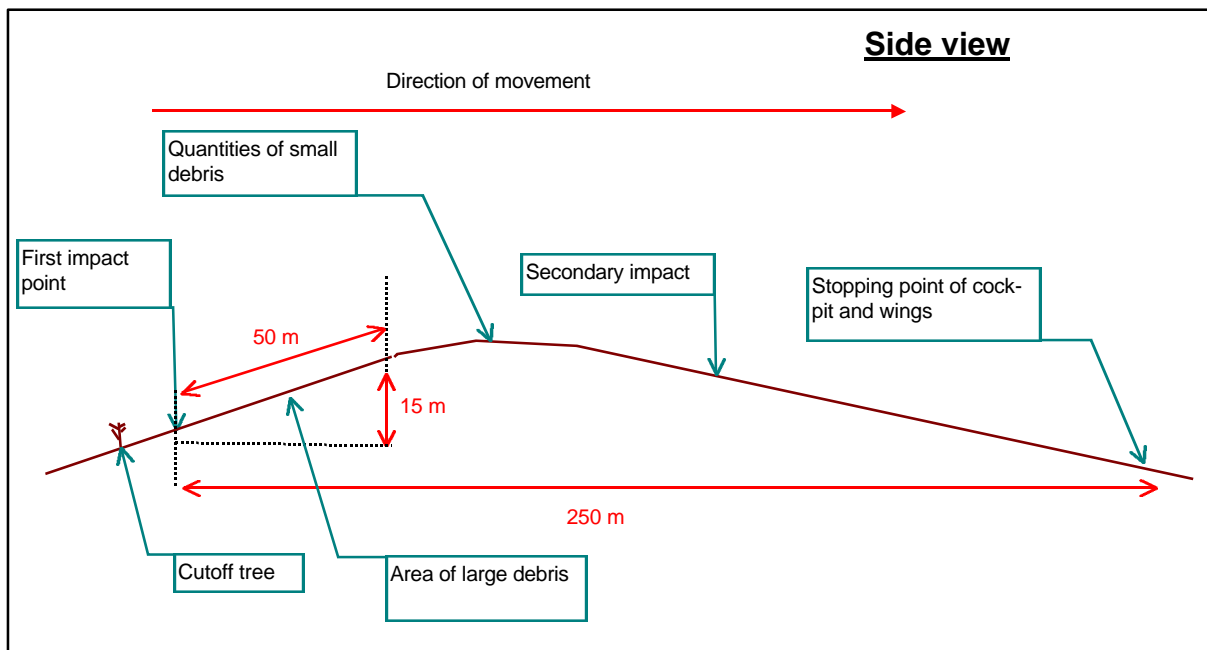
Figure 12 : Side view of site

Twenty-five metres before the impact point, the top of a seven-metre-tall tree had been chopped off on the right side of the track. Then the point of impact of the engine and left propeller slashes were found.

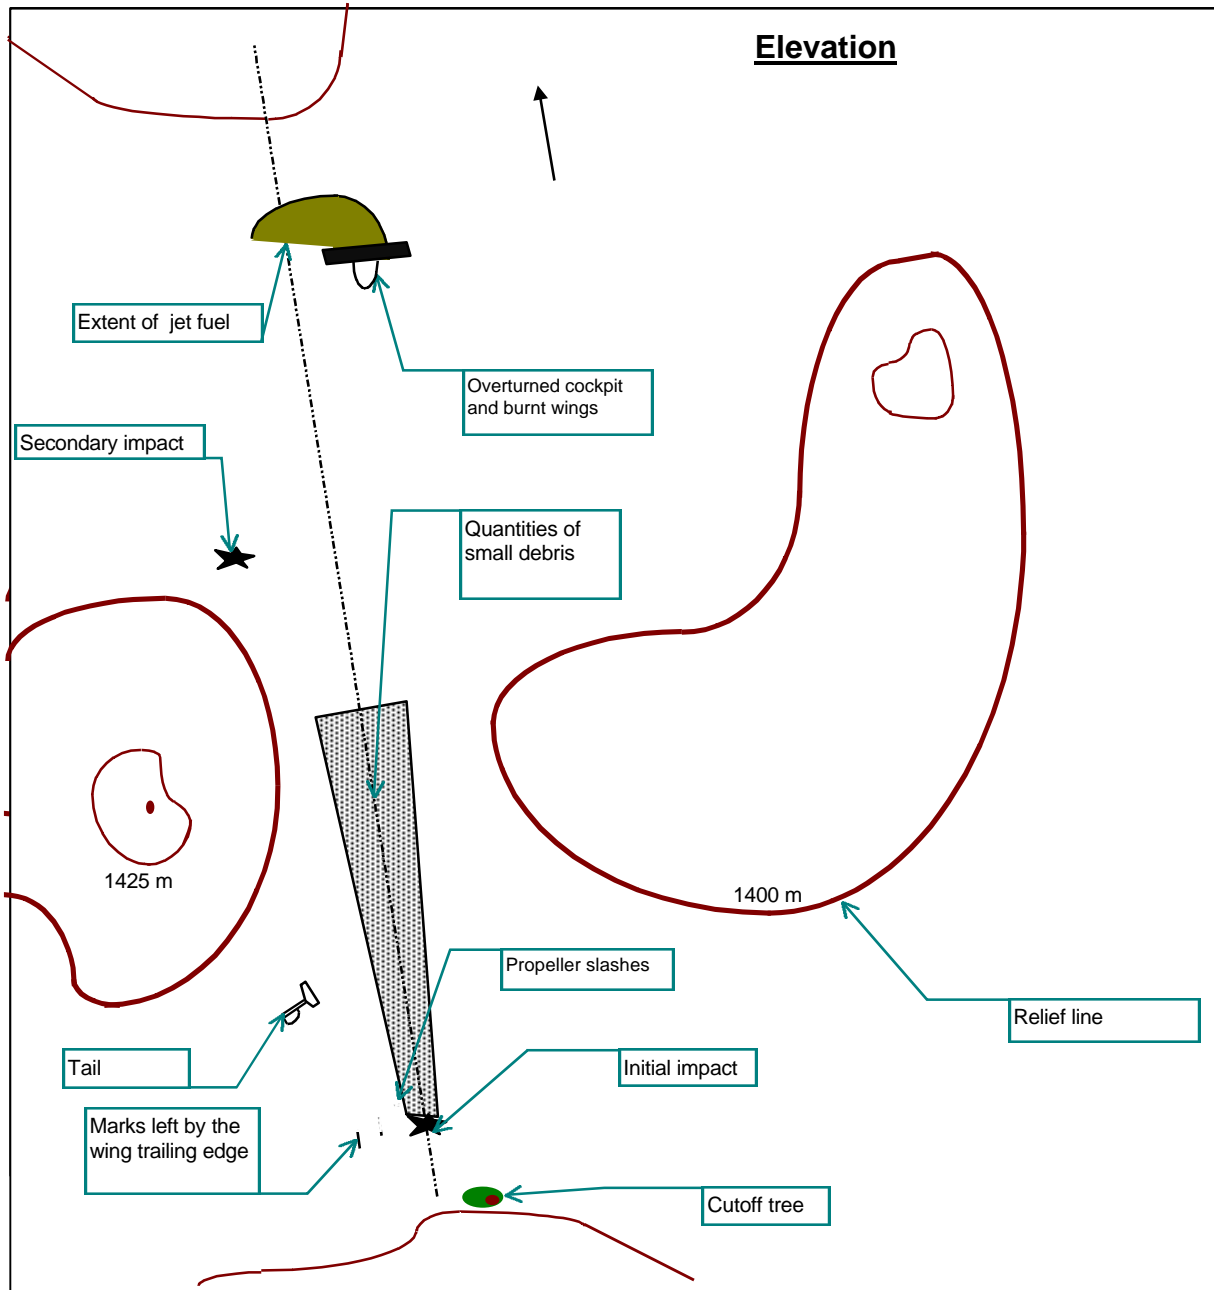
Figure 13 : Accident site seen from above

The fuselage impact point was a little further, about fifty metres from the top of the ridge. The tail, from which half of the left stabiliser was detached, was found on the left.

The debris was then spread about over a length of about 250 m on a line at 250°, on either side of a pass. The lower part of the fuselage had disintegrated on the rocks on a slope rising at 30 %. On the other side of the ridge, the two main landing gears were found in relatively good condition, along with two items of electrical equipment (the GPS and an ADC) and the right engine.

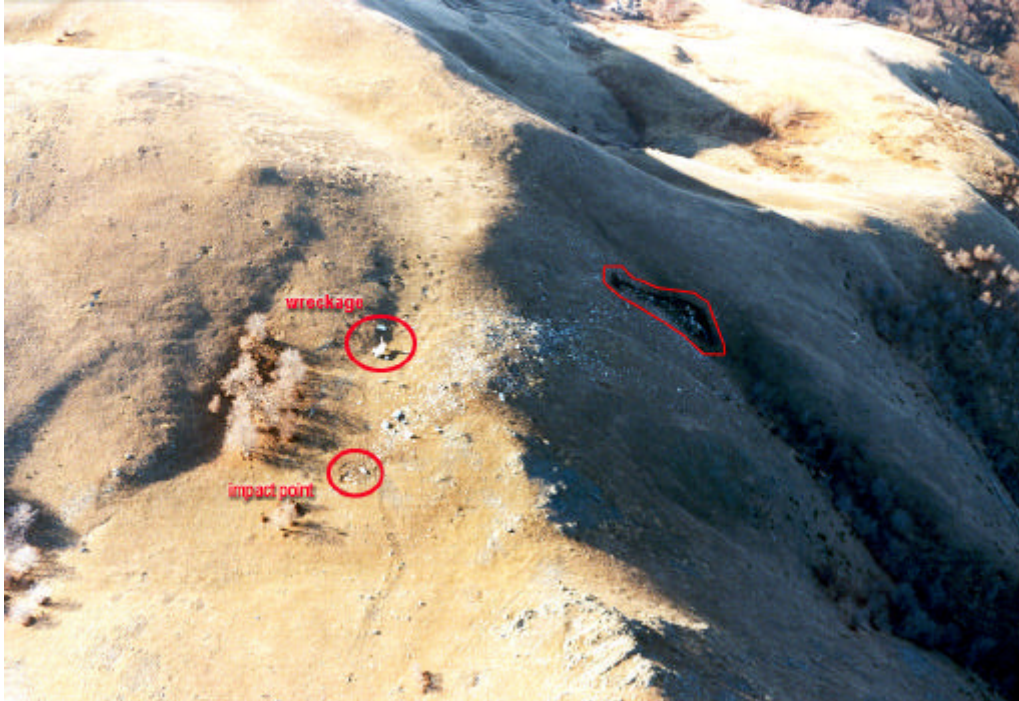
Figure 14 : Debris

At the end of the track, at about 150 m after the ridge, the main part of the fuselage was found : the upper part of the cockpit, the left engine and the wings, showing signs of fire. The cockpit and the wings were upside down. Slightly to the right the engine control pedestal was found.

The GPWS computer was found beyond the pass in the direction of the track. The references noted on the equipment were as follows : manufacturer : AlliedSignal, GPWS Mark II computer 965-0476-088, serial number 10100. Despite extensive additional searches, the left side panel, where the GPWS switch is situated, could not be found.
